Request for completion components for UGS wells for 2015

Customer: NAFTA a.s., UGS Division

Subject: Repair of used christmas trees and modification them for hydraulic control of subsurface safety valve from surface.

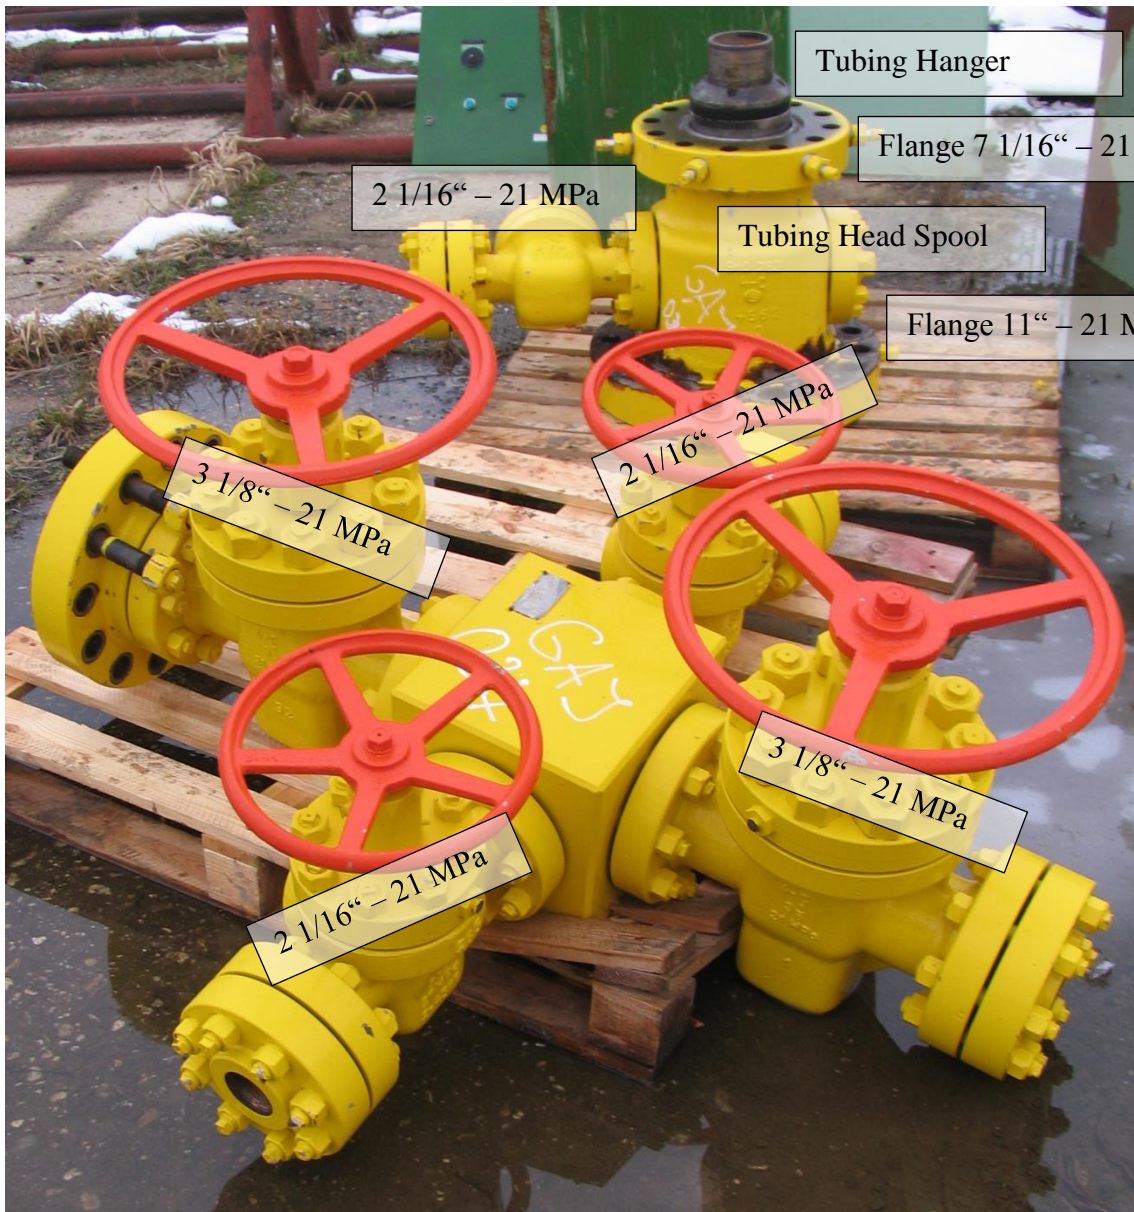
Christmas tree before repair

Description: Christmas tree of working pressure 21 MPa (3000 psi). Master gate valve 3 1/8" – 21 MPa. Swab gate valve 3 1/8" – 21 MPa. Wing gate valves 2 1/16" – 21 MPa. Tubing head spool 11" x 7 1/16" – 21 MPa. Gate valve on the tubing head spool 2 1/16" – 21 MPa. See the picture "Christmas tree before repair" being enclosed below.

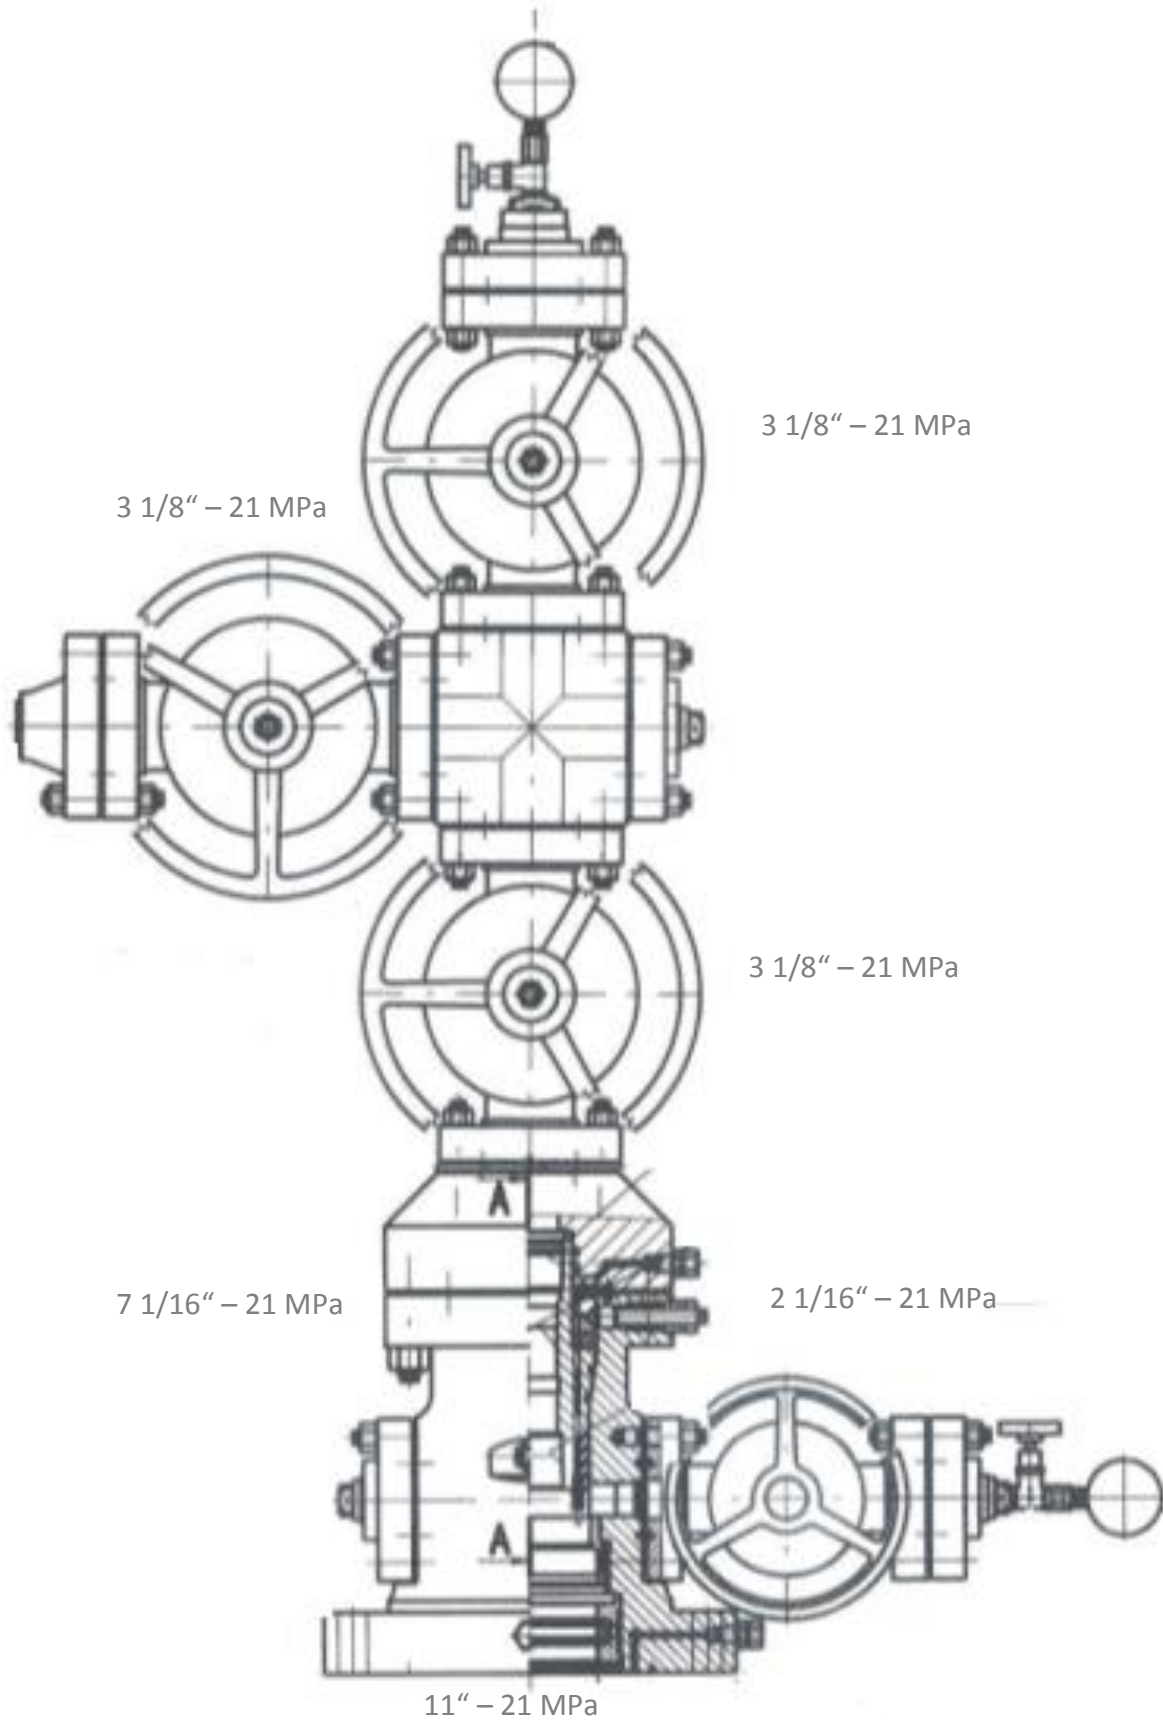
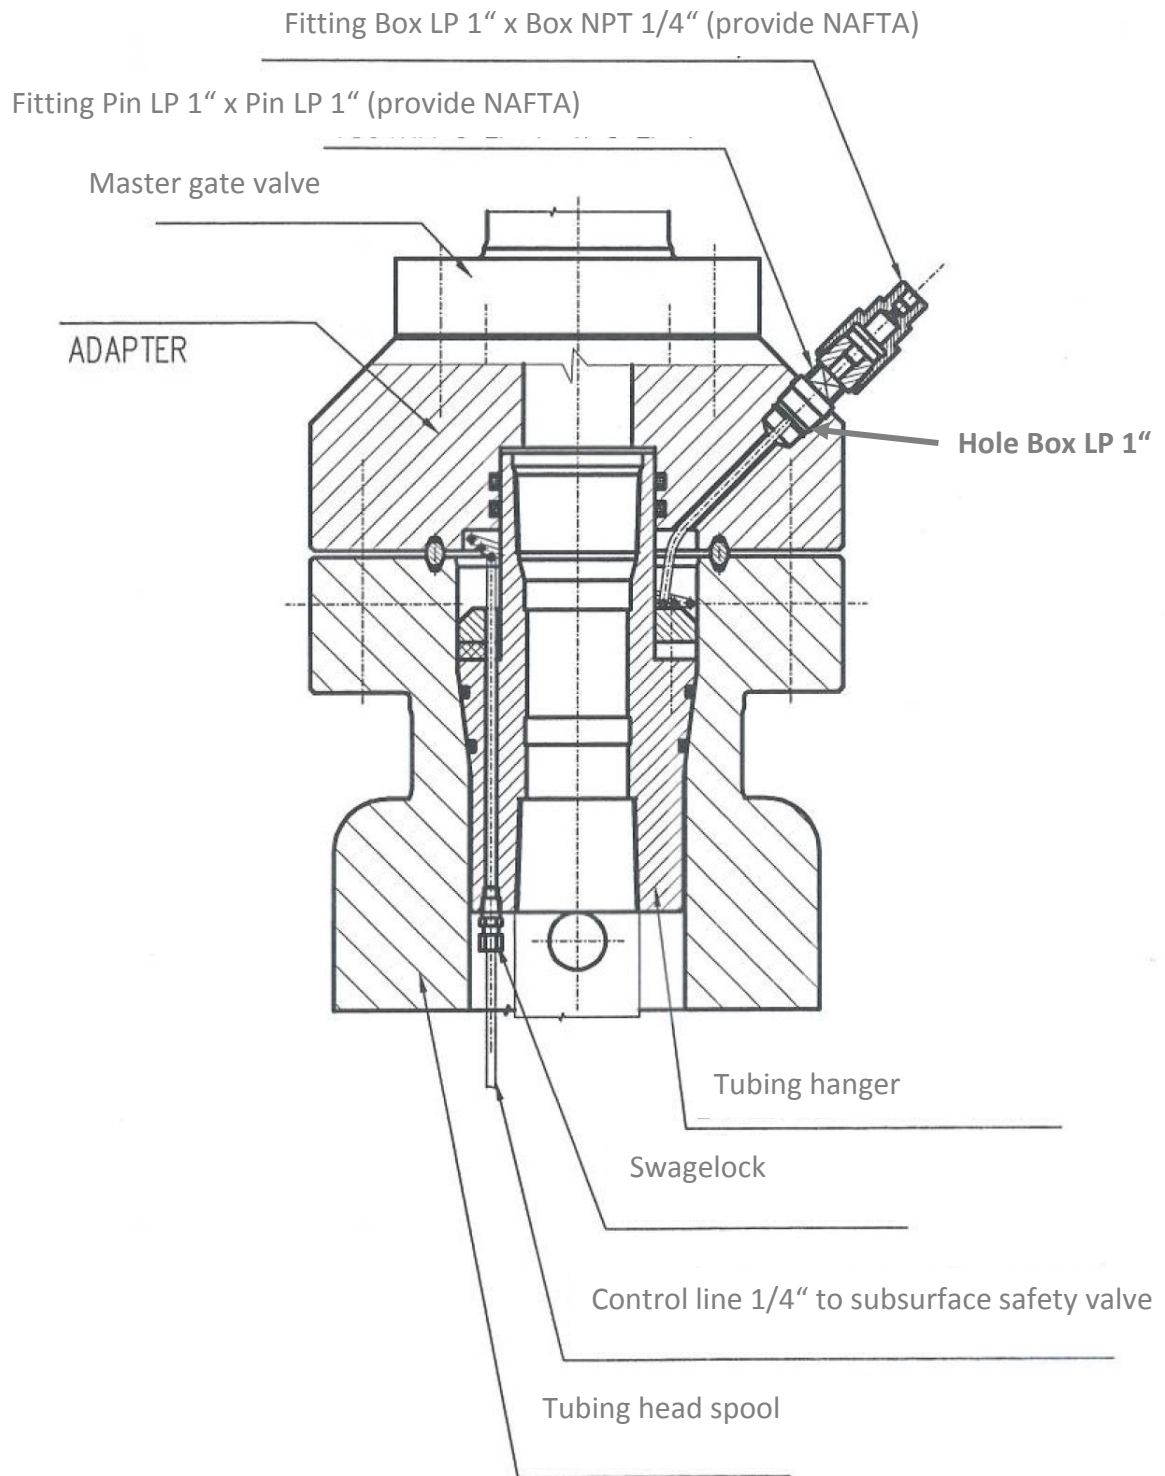
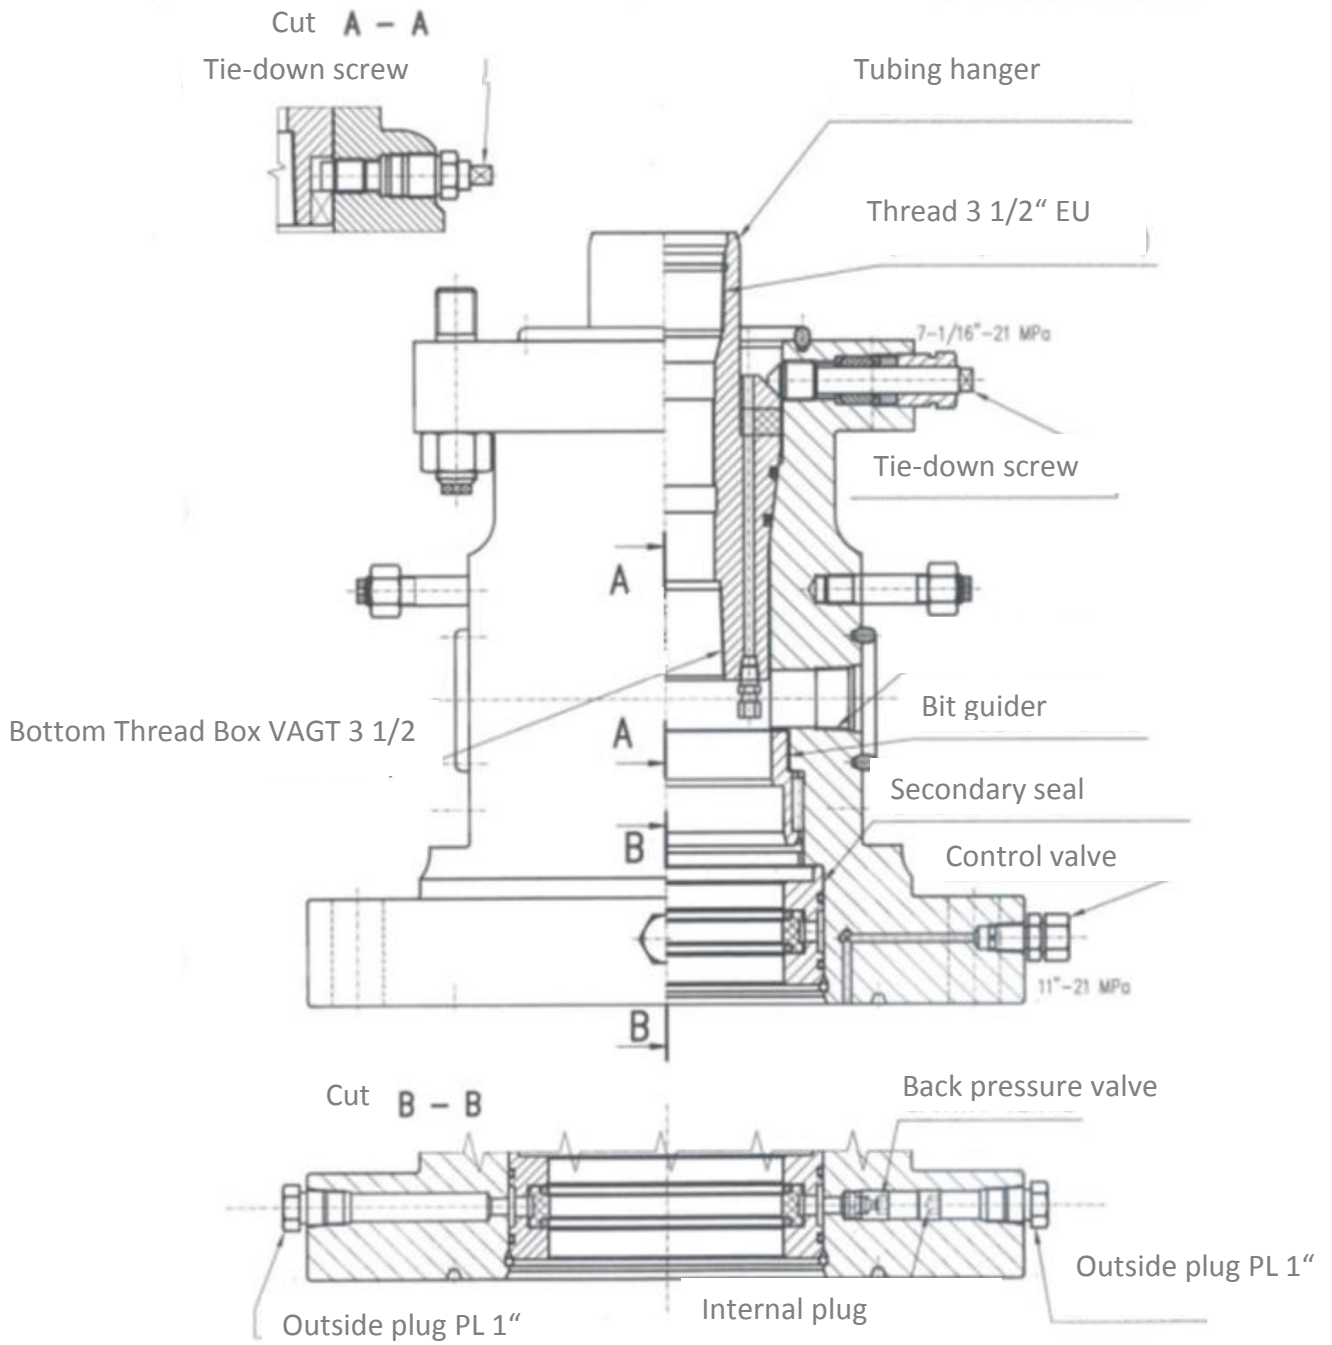
Christmas tree after repair

Item	Amount	Description (See also the picture "Christmas tree after repair" being enclosed below.)
1	10	<p>Christmas tree 3000 psi (21 MPa). API Spec.6A 19th Edition. Material Class: AA. Temperature Class: P (-29°C - +82°C). PSL 1, PR 1.</p> <p>Tubing head spool section 11" x 7 1/16". Secondary seal for 7" casing. Inside diameter 159 mm of guider (Bit Pilot) above secondary sealings.</p> <p>On the right side: Gate valve 2 1/16" (from delivered christmas tree) with threaded flange with hole with 2" LP thread with threaded plug with needle valve with gauge. Check and repair the gate valve if it is out of order.</p> <p>On the left side: Threaded flange with hole with 2" LP thread with blind plug 2" LP.</p> <p>Tubing hanger new with top Box 3 1/2" EU x bottom Box 3 1/2" 9,2 lb/ft (Voest Alpine) thread. Tubing hanger with thread for test plug. Type of thread of the test plug shall be made according to the thread from the test plug being delivered by customer. Tubing hanger shall be adapted for installation of 1/4" control line to surface control of subsurface safety valve.</p> <p>Adapter new 7 1/16" x 3 1/8" shall be adapted for installation of 1/4" control line to surface control of subsurface safety valve.</p> <p>Control line has to go through tubing hanger and adapter without interruption of control line. In the place of the end of the hole for control line on the outside of the adapter shall be threaded hole with 1" LP thread.</p> <p>Master gate valve 3 1/8" new, AA, PSL 2, PR 1.</p> <p>Gate valve 3 1/8" NAFTA (from delivered christmas tree) with welding</p>

<p>neck with outside diameter 88,9 mm x inside diameter 74,4 mm on the left side. Check and repair the gate valve if it is out of order.</p> <p>Without gate valve on the right side. On the right side threaded flange 3 1/8 with hole with 2" LP thread with threaded plug.</p> <p>Swab gate valve 3 1/8" NAFTA (from delivered christmas tree) with threaded flange 3 1/8" with hole with 3" LP thread with threaded plug with needle valve with gauge. Check and repair swab valve if it is out of order.</p> <p>Including bolts and gaskets and plastic packing material for the secondary seal assembly.</p> <p>Yellow colour.</p> <p>Documentation:</p> <p>Protocol of pressure test</p> <p>Letter of conformity</p> <p>Operating and service instruction.</p> <p>Note</p> <p>Attach a picture of christmas tree to your quotation.</p>
--	------------------------------------------------------------------------------------------------------------------------------------------------------------------------------------------------------------------------------------------------------------------------------------------------------------------------------------------------------------------------------------------------------------------------------------------------------------------------------------------------------------------------------------------------------------------------------------------------------------------------------------------------------------------------------------------------------------------------------------------------------------------------------------------------------------------------------------------------
